P8B-C Series How to differentiate REV 1.0x and REV 2.0x

By ASUS Server BU Sep 6th, 2011

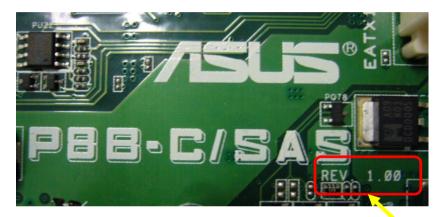
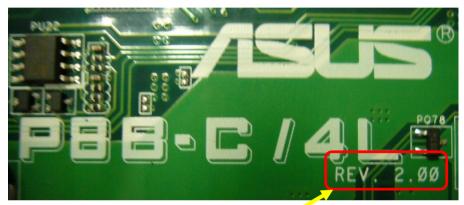
How to differentiate the motherboard PCB revision location

R1.0x (Z9s)

R2.0x (AST1100)
